# CASE STUDY: BELT TRACKING

A major mining organization was having regular belt tracking issues with its overland conveyor resulting in regular hours of production loss and downtime. Downtime was due to belt tracking issues caused by multiple splices on the belt not being square, and earth movement to the structure over time.

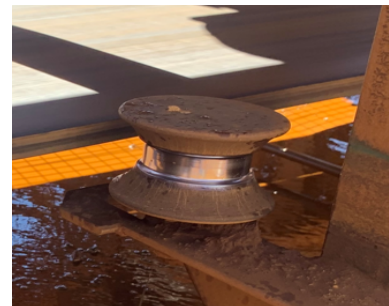
It was evident tracking was at its worst at the tail end due to witness shine marks on the guide rollers and clear left to right belt movement across the pulley while the belt was in service.

Example of shine marks on guide rollers from constant belt tracking contact.

2x REMATRACK FTX (flat return trackers) and 1x REMATRACK TTX (dynamic trough tracker) were recommended as a solution and trailed. See diagrams for locations.
