REMATRACK TTX stops production loss at NSW Coal Fired Power Generator

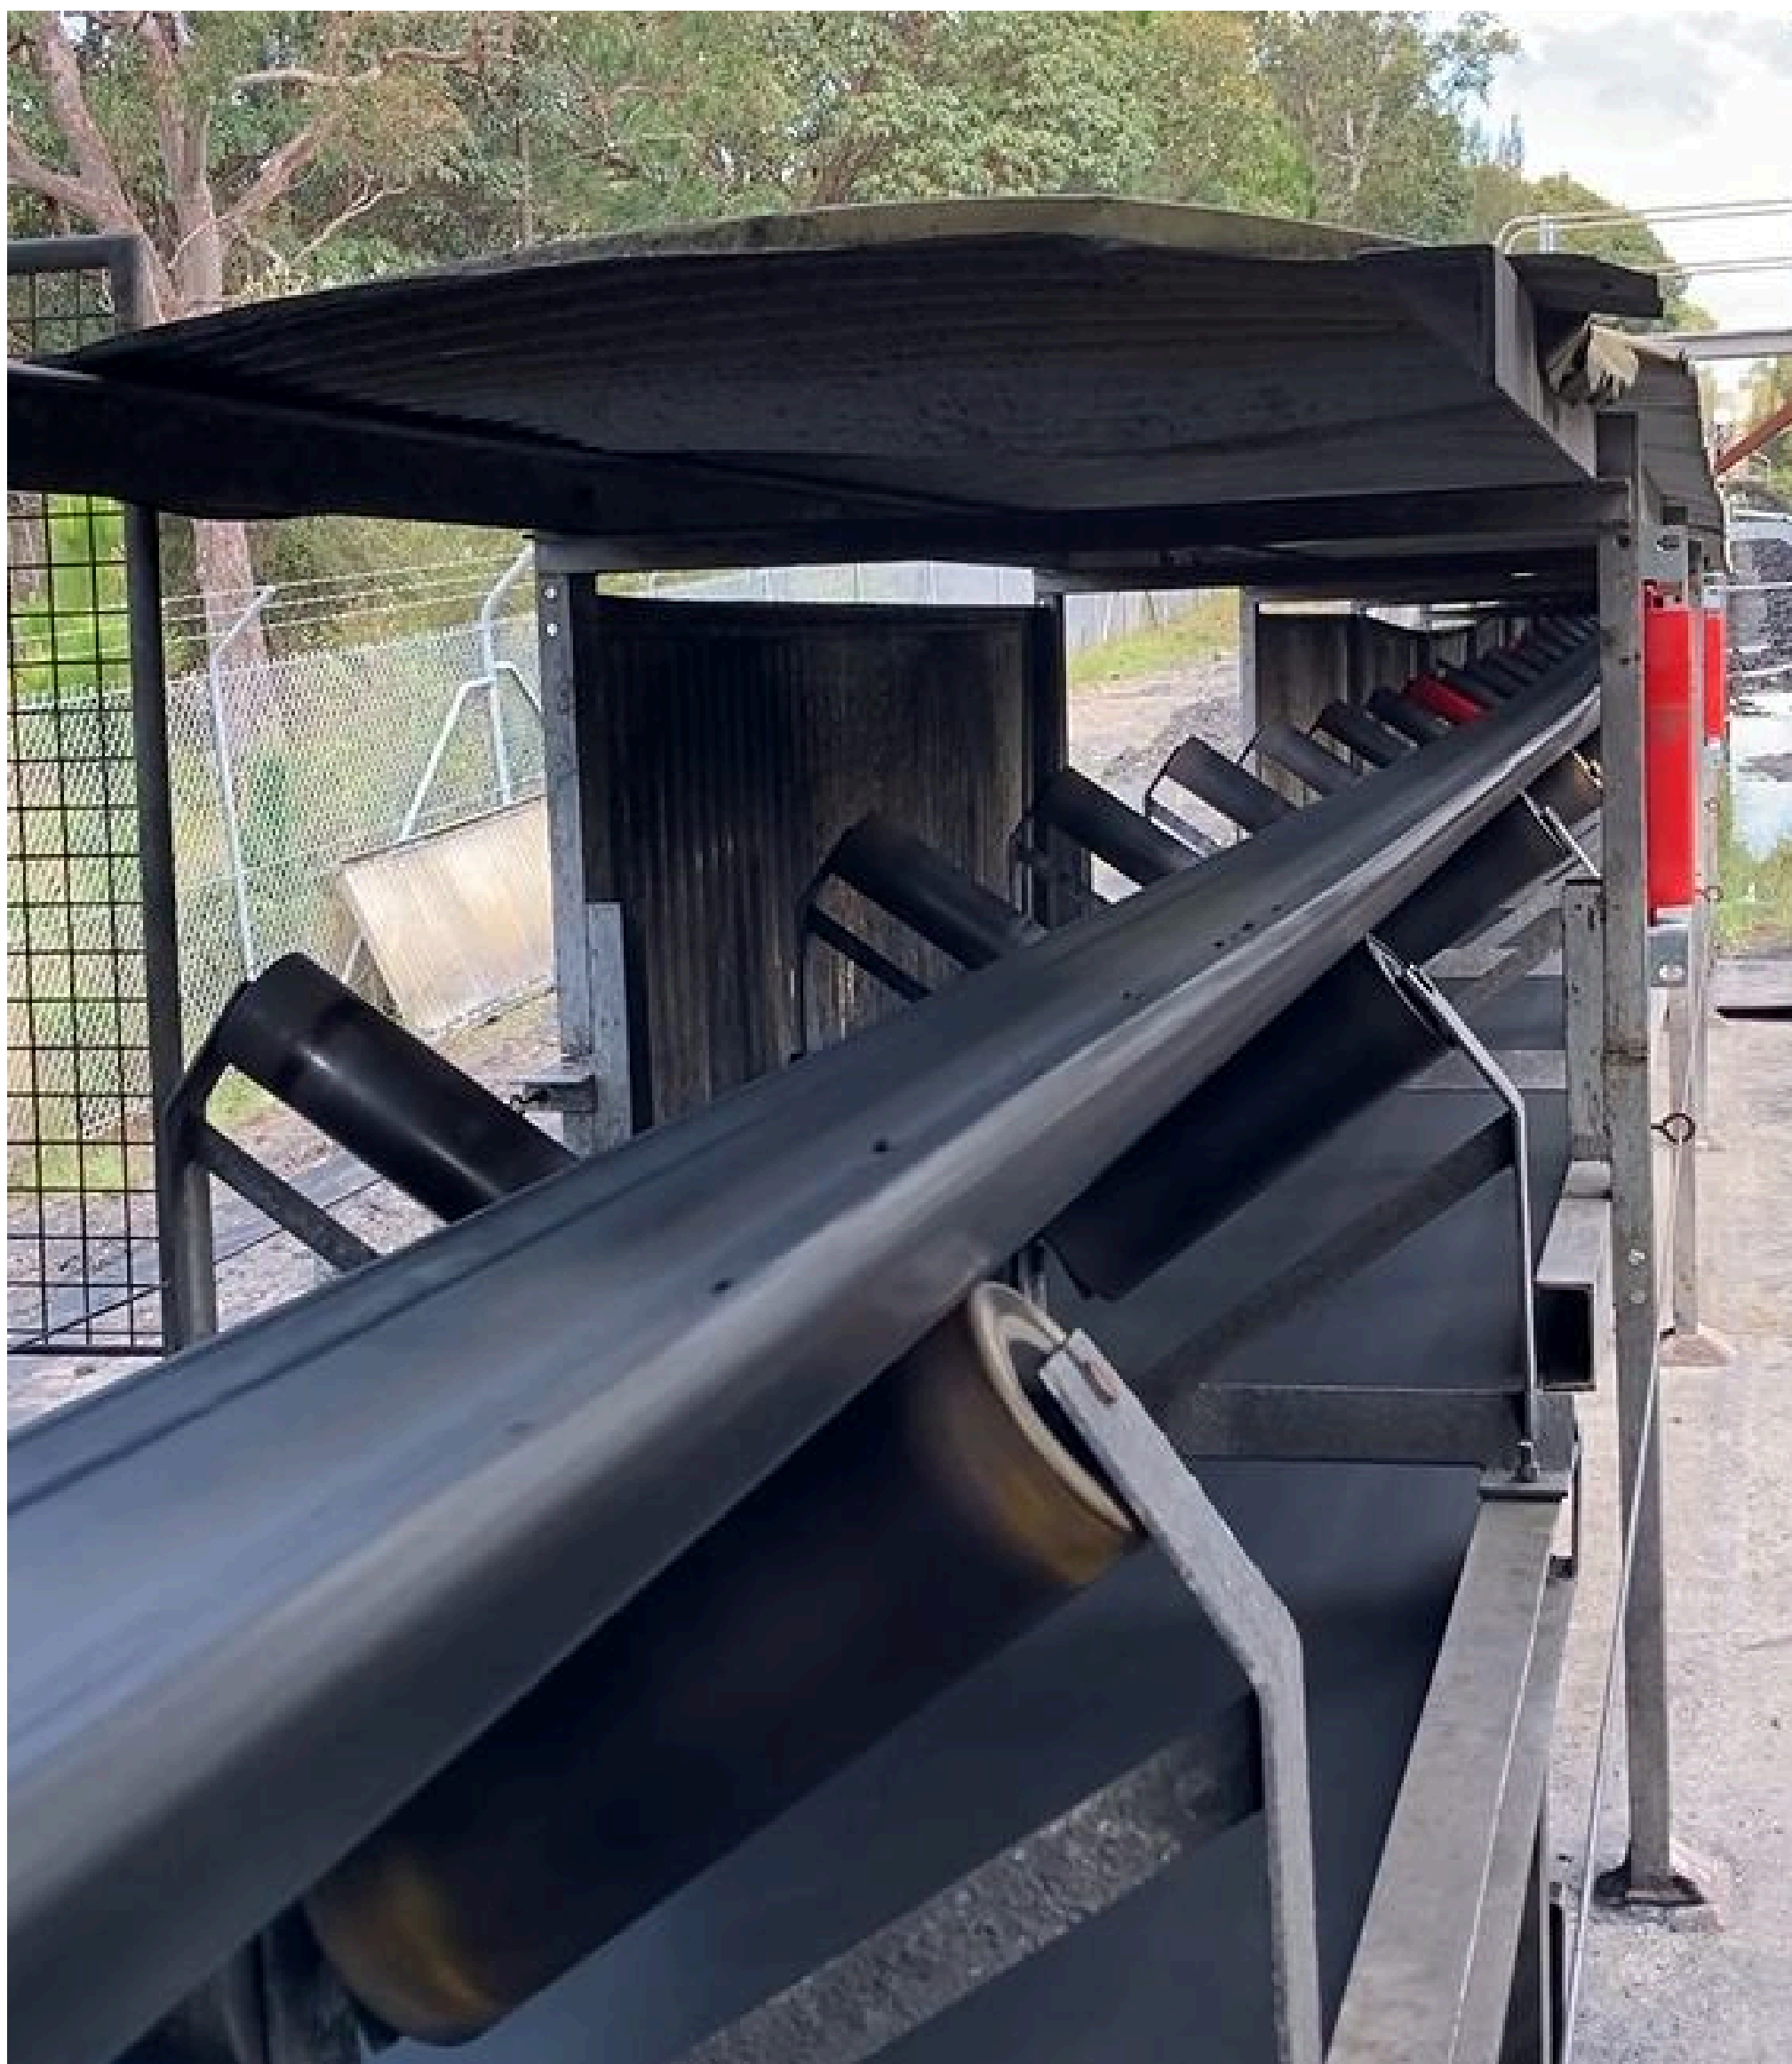
Tracking before installation of REMATRACK TTX

When REMA TIP TOP's NSW service division performed a scheduled belt replacement on the Power Generator's overland conveyor system, it was found that one of the three belt cassettes reacted outside of Australian standards for tracking parameters.

Due to the critical nature of the conveyor, there was no time available to order and change out the sub-standard section of belt. The mistracking belt was already causing production loss, and if left unresolved would mistrack so severely the site would risk significant structure damage, which would cause disruptive and costly downtime and maintenance.

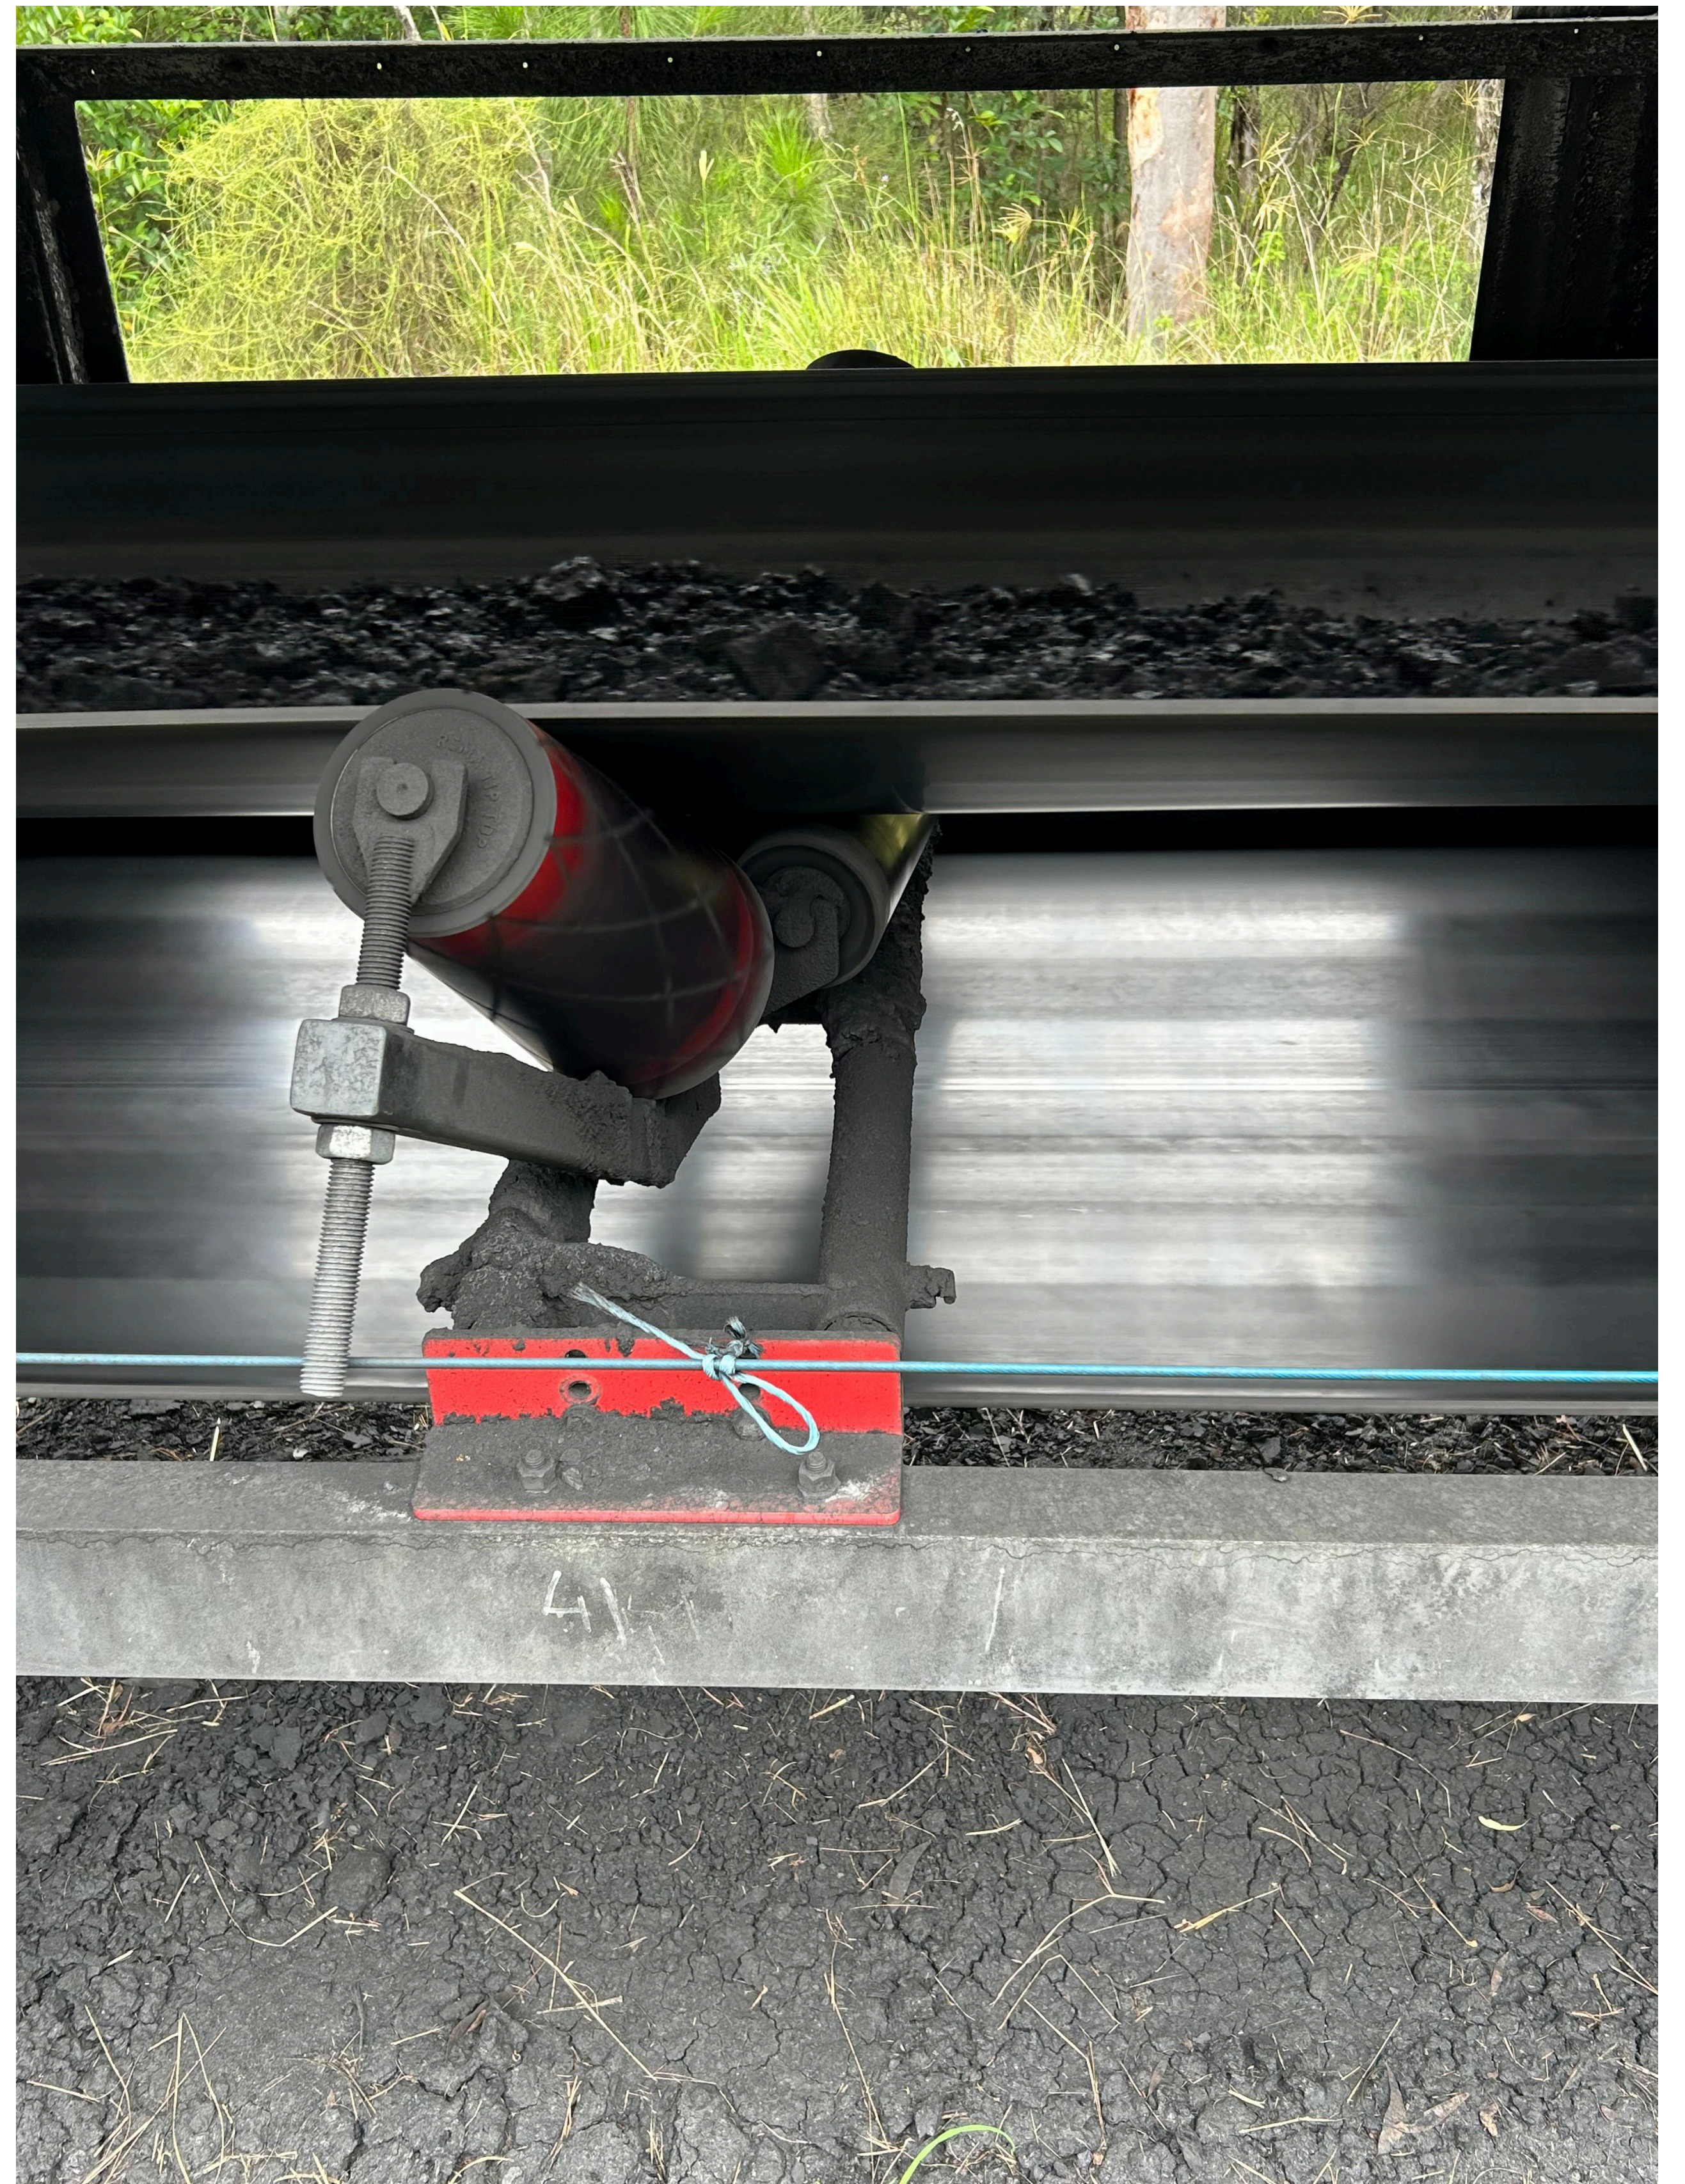
24 months after installation of REMATRACK TTX

“These trackers have now been installed for over 24 months and are still tracking the belt perfectly.”

Four trackers were installed 150 meters apart along the 600 meters of mistracking belt. As soon as the tracking units were installed, the belt immediately aligned; putting a stop to the production loss. Although best practice would be to address the root of the mistracking issue by replacing the non-conforming belt, REMATRACK TTX presented a long-term rectification that immediately allowed the belt to operate to its designed capacity. This meant no future risk of structure damage and a complete stop to the production loss that occurred pre-installation.
