# REMATRACK TTX stops production loss at NSW Coal Fired Power Generator

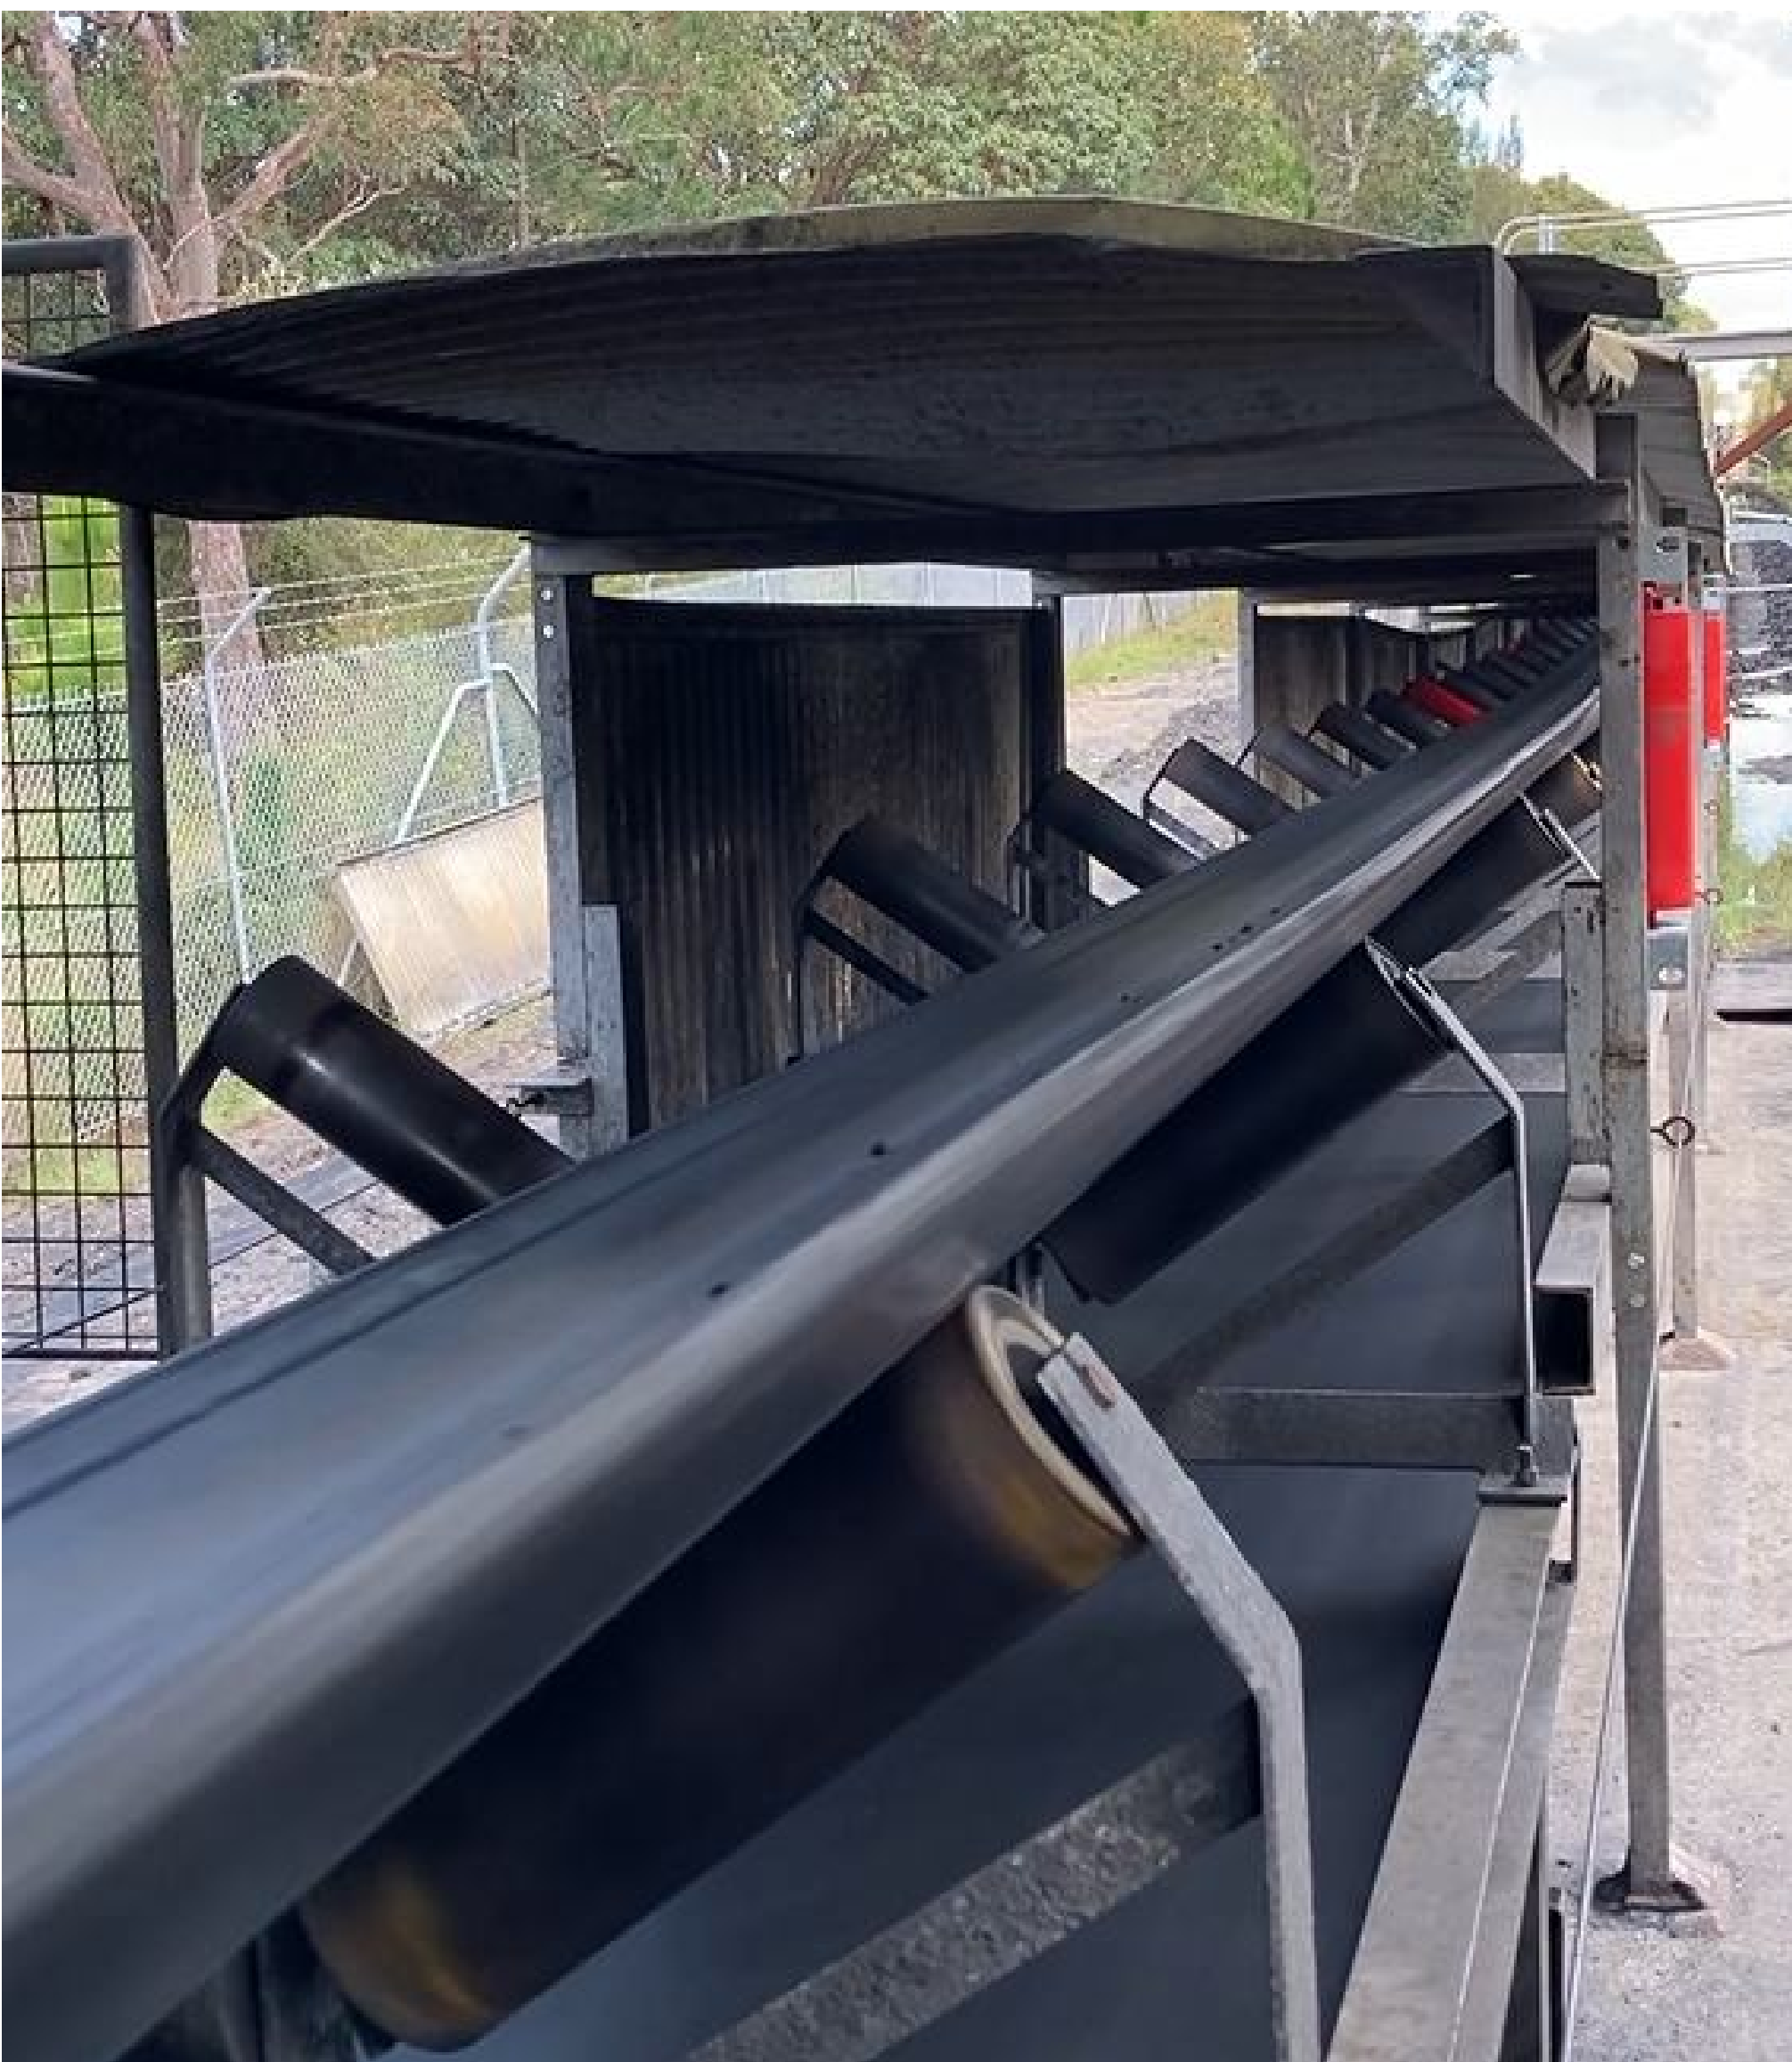
*Tracking before installation of REMATRACK TTX*

*Every product that goes on your belt line has an impact.* When a NSW Coal Fired Power Generator purchased a belt from an external supplier, they immediately faced tracking issues due to the poor quality of the belt.

When REMA TIP TOP's NSW service division performed a scheduled belt replacement on the site's overland conveyor system, it was found that one of the three belt cassettes reacted outside of Australian standards for tracking parameters.

Due to the critical nature of the conveyor, there was no time available to order and change out the sub-standard section of belt. The mistracking belt was already causing production loss, and if left unresolved would mistrack so severely the site would risk significant structure damage, which would cause disruptive and costly downtime and maintenance.

Immediate action by the Rema Tip Top service team was taken to install four REMATRACK TTX units in multiple areas along the beltline. REMATRACK TTX is a premium trough tracker manufactured using a one-step casting method. This one-step casting method results in having no joins on the rolls, completely eliminating one of the most common causes of premature wear on lagged trackers. The tracker is also lagged using a specially formulated polyurethane that features high wear-resistance compounds.

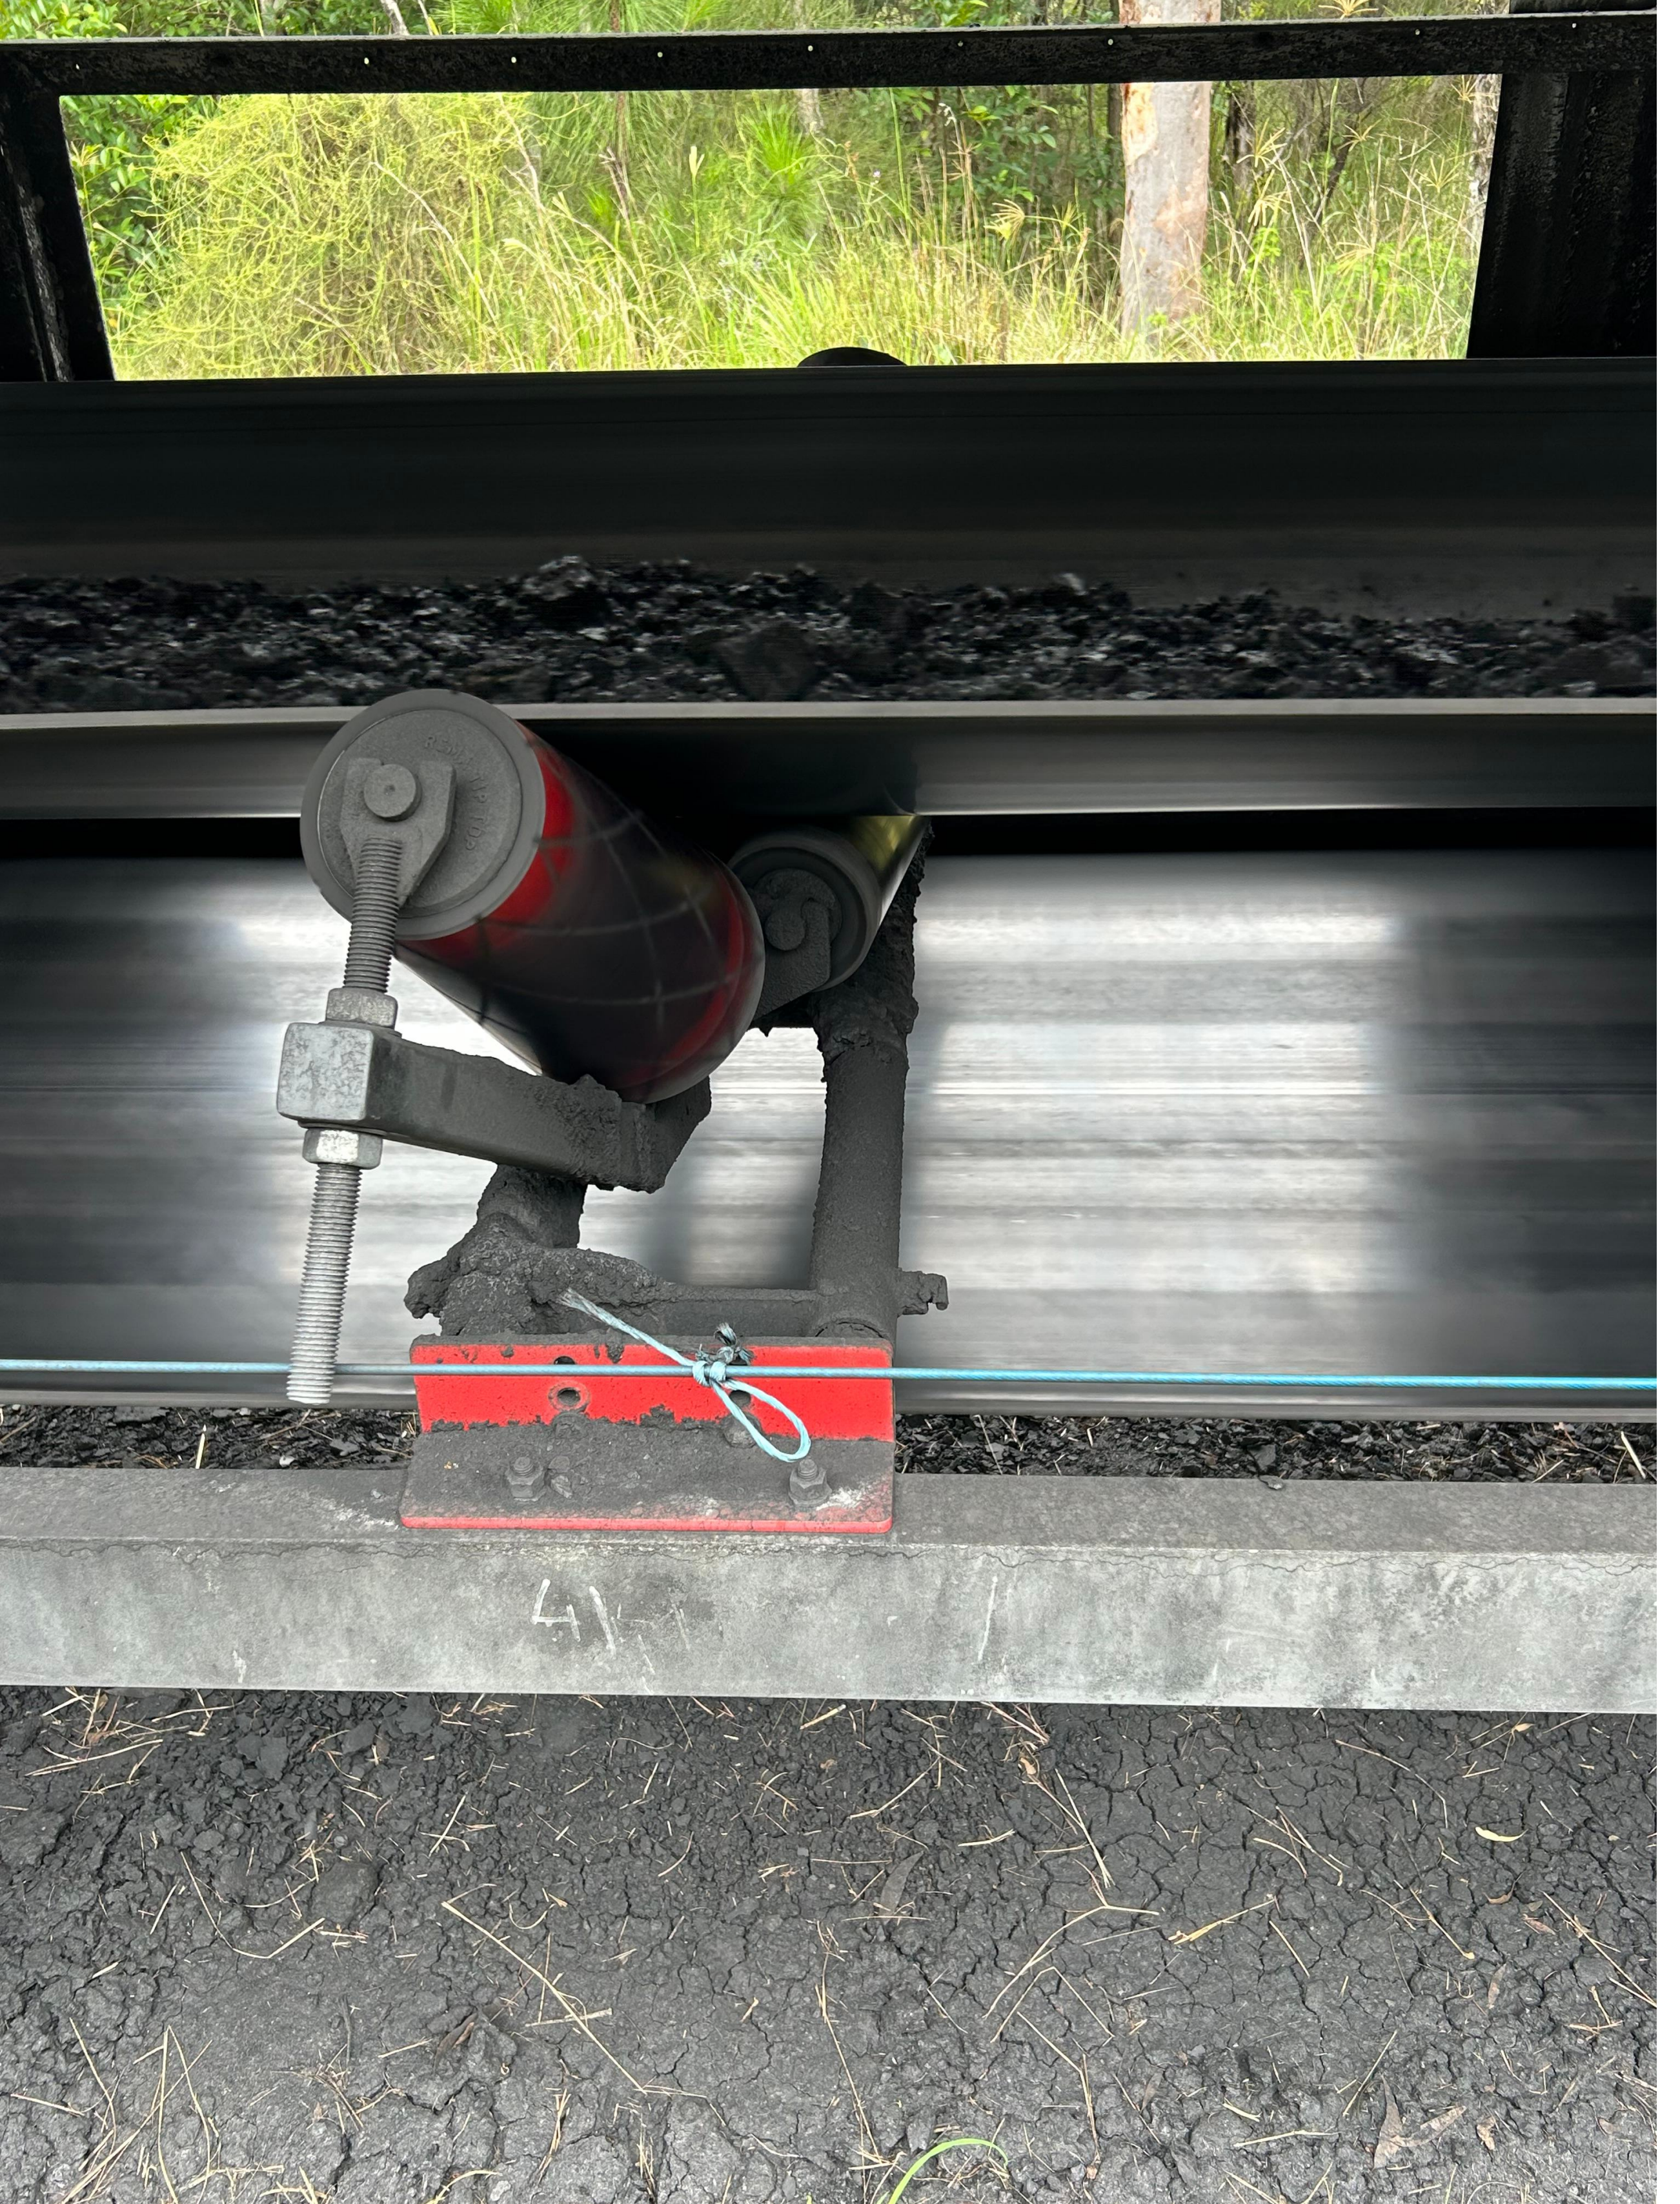
24 months after installation of REMATRACK TTX

“These trackers have now been installed for over 24 months and are still tracking the belt perfectly.”

Four trackers were installed 150 meters apart along the 600 meters of mistracking belt. As soon as the tracking units were installed, the belt immediately aligned; putting a stop to the production loss. Although best practice would be to address the root of the mistracking issue by replacing the non-conforming belt, REMATRACK TTX presented a long-term rectification that immediately allowed the belt to operate to its designed capacity. This meant no future risk of structure damage and a complete stop to the production loss that occurred pre-installation.
