REMATRACK TTX stops production loss at NSW Coal Fired Power Generator

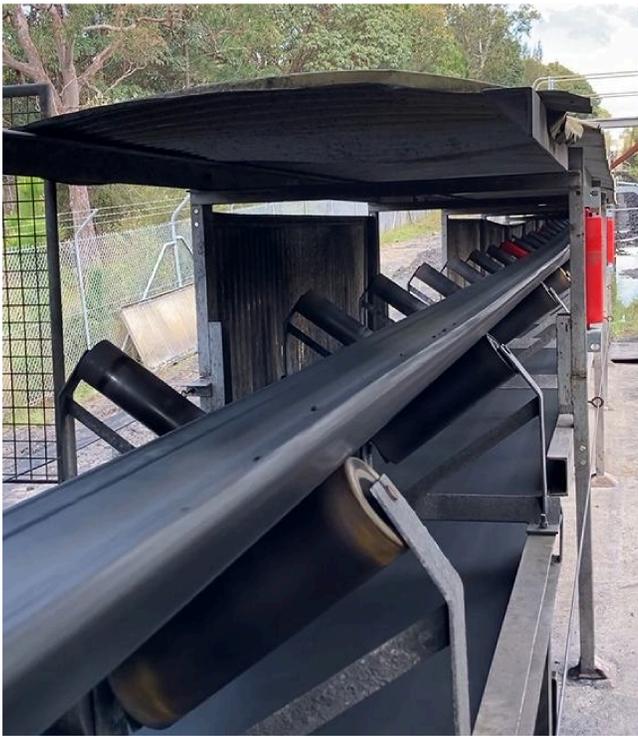
Tracking before installation of REMATRACK TTX

When REMA TIP TOP's NSW service division performed a scheduled belt replacement on the Power Generator's overland conveyor system, it was found that one of the three competitor-supplied belt cassettes reacted outside of Australian standards for tracking parameters.

The belt in question is a 1.75km long critical supply belt used to convey coal from the underground mine. The belt was 1050mm wide, running at 5m/sec with over 3,500 tonnes per hour loaded onto the belt.

Due to the critical nature of the conveyor, there was no time available to order and change out the sub-standard section of belt. The mistracking belt was already causing production loss, and if left unresolved would mistrack so severely the site would risk significant structure damage, which would cause disruptive and costly downtime and maintenance.

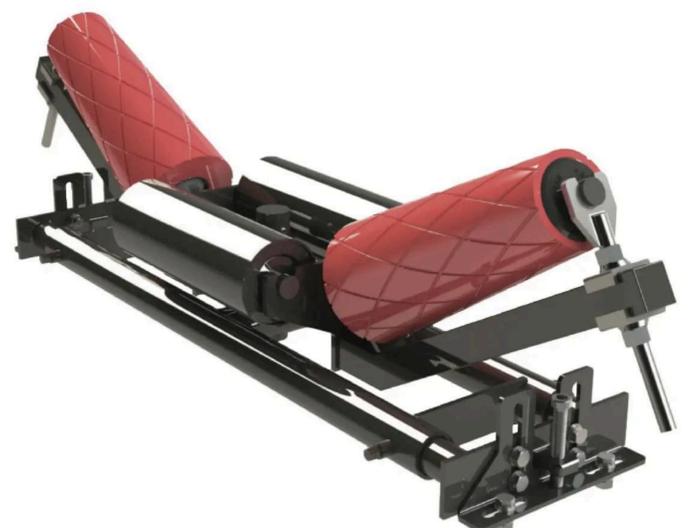
Immediate action by the Rema Tip Top service team was taken to install four REMATRACK TTX units in multiple areas along the beltline. REMATRACK TTX is a premium trough tracker manufactured using a one-step casting method. This one-step casting method results in having no joins on the rolls, completely eliminating one of the most common causes of premature wear on lagged trackers. The tracker is also lagged using a specially formulated polyurethane that features high wear-resistance compounds.

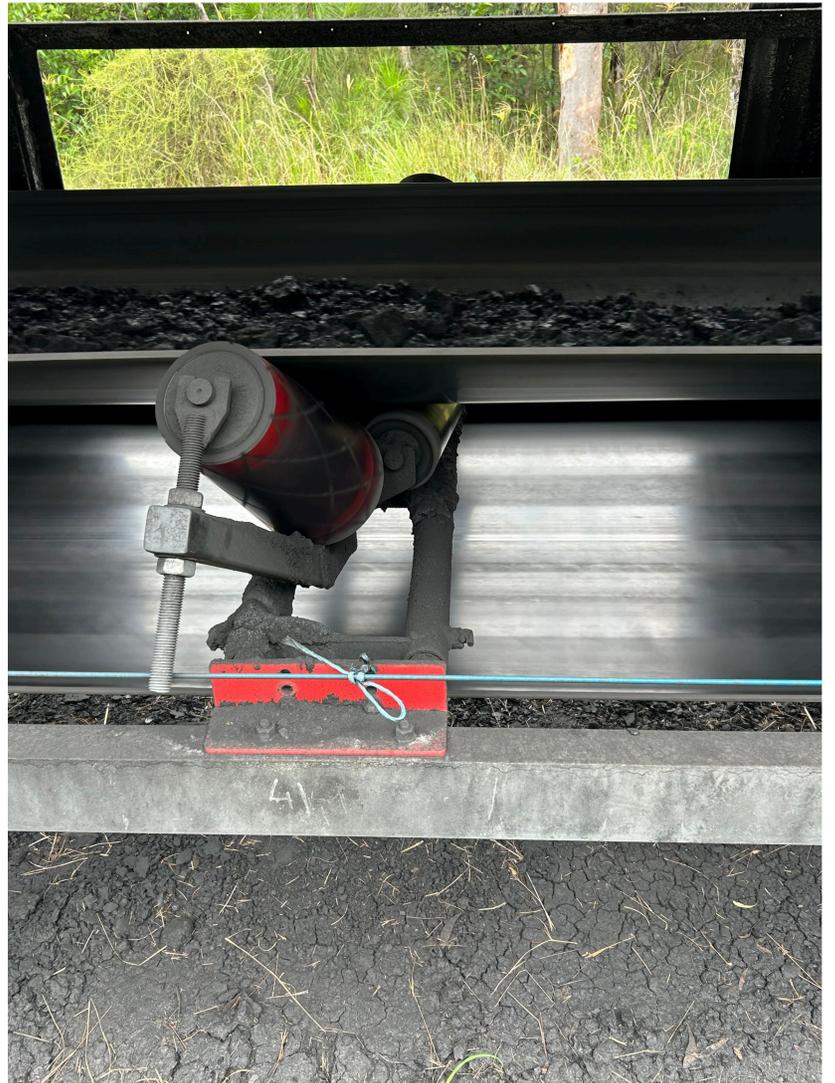
24 months after installation of REMATRACK TTX

“These trackers have now been installed for over 24 months and are still tracking the belt perfectly.”

Four trackers were installed 150 meters apart along the 600 meters of mistracking belt. As soon as the tracking units were installed, the belt immediately aligned; putting a stop to the production loss. Although best practice would be to address the root of the mistracking issue by replacing the non-conforming belt, REMATRACK TTX presented a long-term rectification that immediately allowed the belt to operate to its designed capacity. This meant no future risk of structure damage and a complete stop to the production loss that occurred pre-installation.
