REMATRACK TTX stops production loss at NSW Coal Fired Power Generator

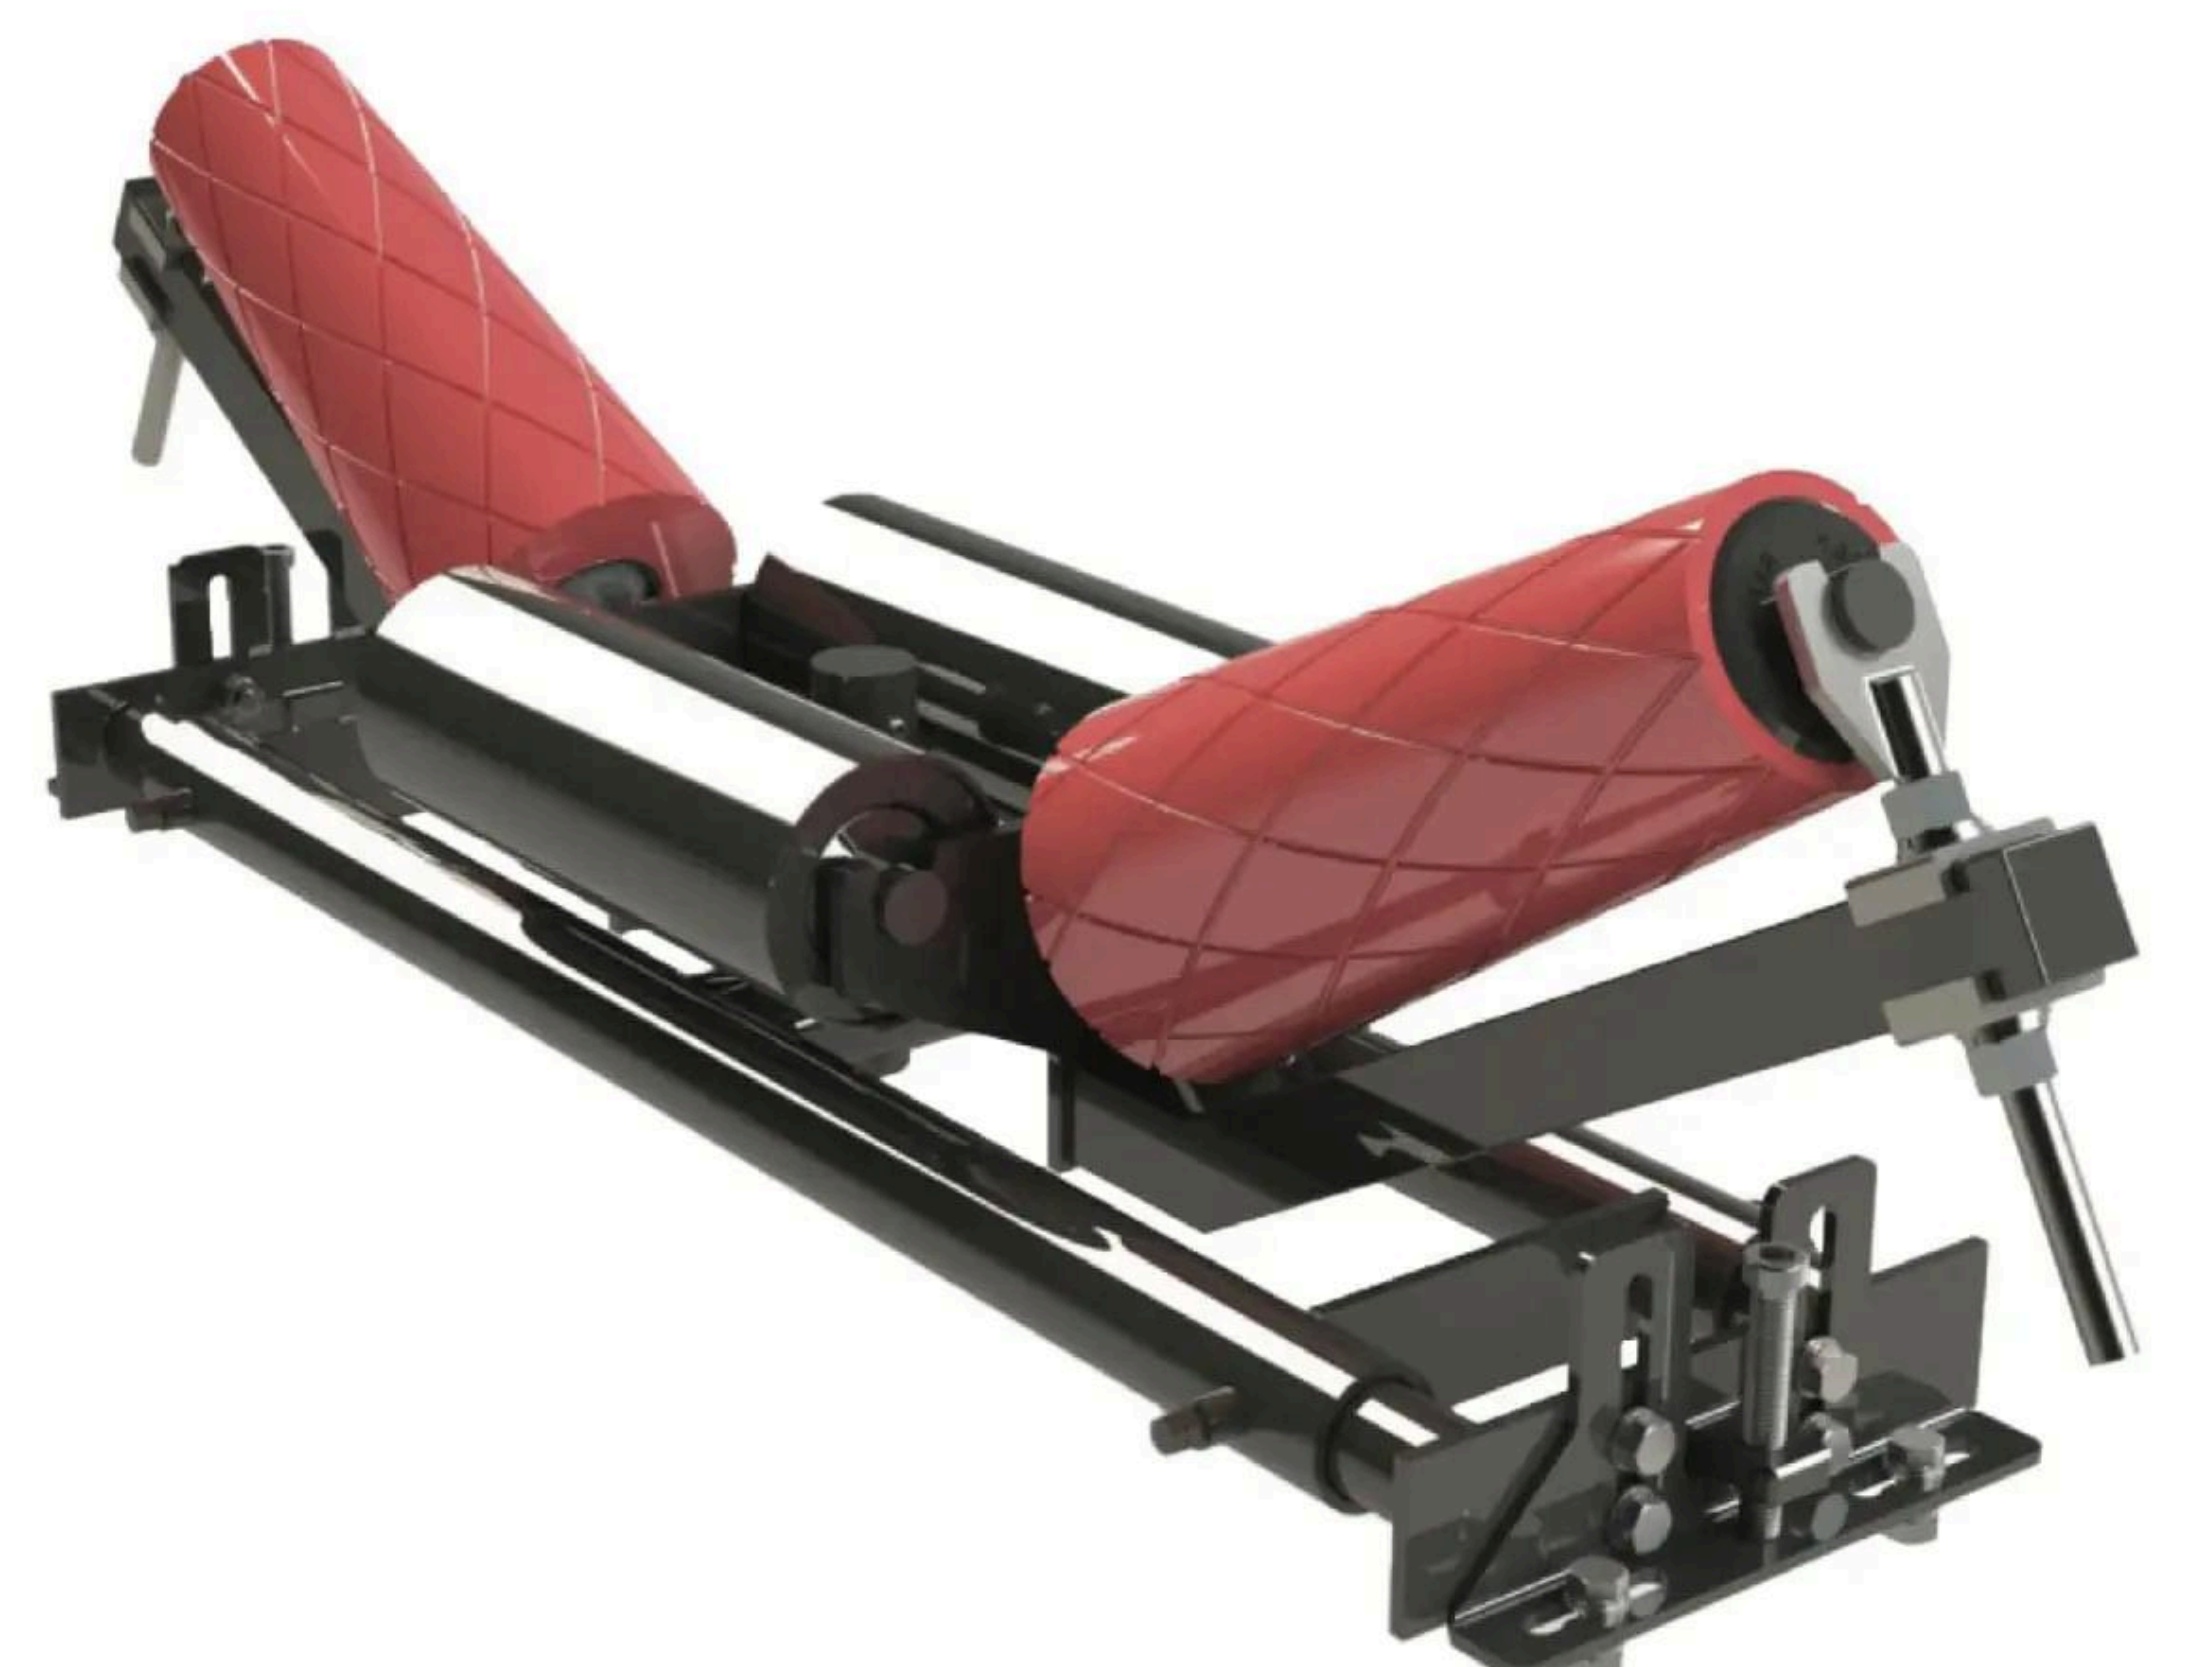
Immediate action by the Rema Tip Top service team was taken to install four REMATRACK TTX units in multiple areas along the beltline. REMATRACK TTX is a premium trough tracker manufactured using a one-step casting method. This one-step casting method results in having no joins on the rolls, completely eliminating one of the most common causes of premature wear on lagged trackers. The tracker is also lagged using a specially formulated polyurethane that features high wear-resistance compounds.

Four trackers were installed 150 meters apart along the 600 meters of mistracking belt. As soon as the tracking units were installed, the belt immediately aligned; putting a stop to the production loss. Although best practice would be to address the root of the mistracking issue by replacing the non-conforming belt, REMATRACK TTX presented a long-term rectification that immediately allowed the belt to operate to its designed capacity. This meant no future risk of structure damage and a complete stop to the production loss that occurred pre-installation.
