# REMATRACK TTX stops production loss at NSW Coal Fired Power Generator

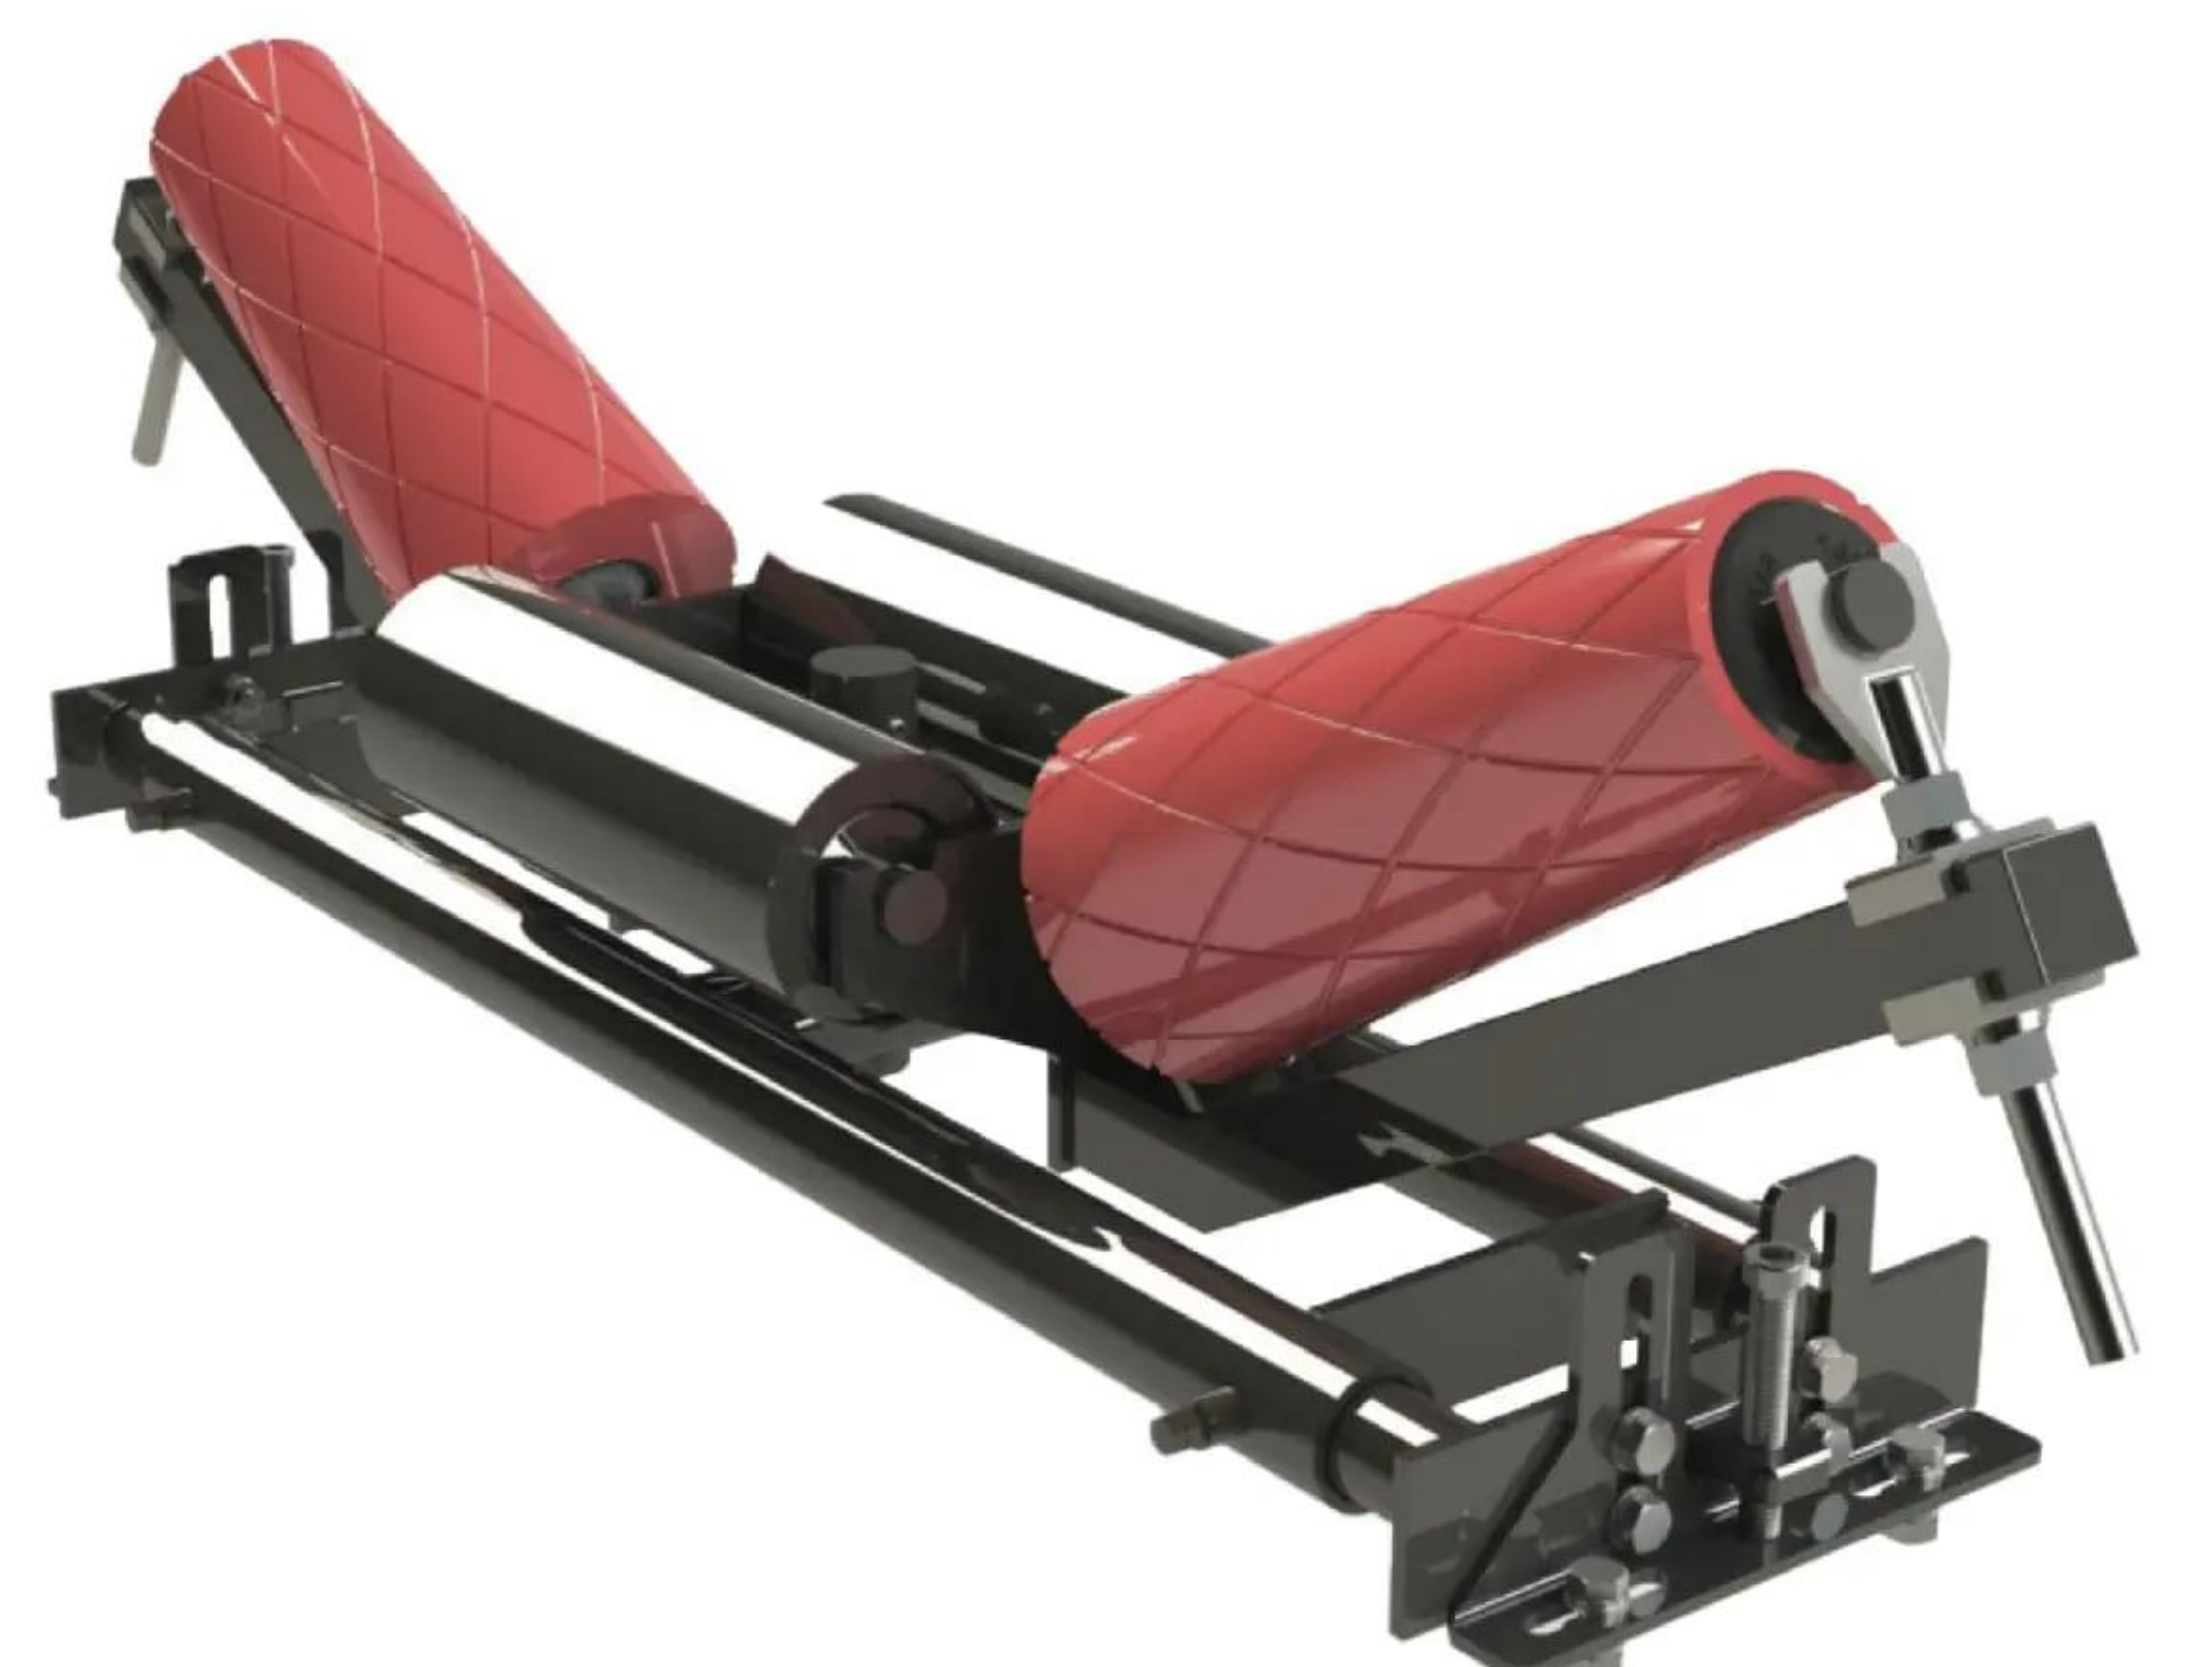
Immediate action by the Rema Tip Top service team was taken to install four REMATRACK TTX units in multiple areas along the beltline. REMATRACK TTX is a premium trough tracker manufactured using a one-step casting method. This one-step casting method results in having no joins on the rolls, completely eliminating one of the most common causes of premature wear on lagged trackers. The tracker is also lagged using a specially formulated polyurethane that features high wear-resistance compounds.

Four trackers were installed 150 meters apart along the 600 meters of mistracking belt. As soon as the tracking units were installed, the belt immediately aligned; putting a stop to the production loss. Although best practice would be to address the root of the mistracking issue by replacing the non-conforming belt, REMATRACK TTX presented a long-term rectification that immediately allowed the belt to operate to its designed capacity. This meant no future risk of structure damage and a complete stop to the production loss that occurred pre-installation.
